# Virtual Field Visit at Sreemongal Municipality

**Objectives:** Monitoring of environmental facilities as agreed in approved Environmental Assessment Report of Sreemongal Municipality

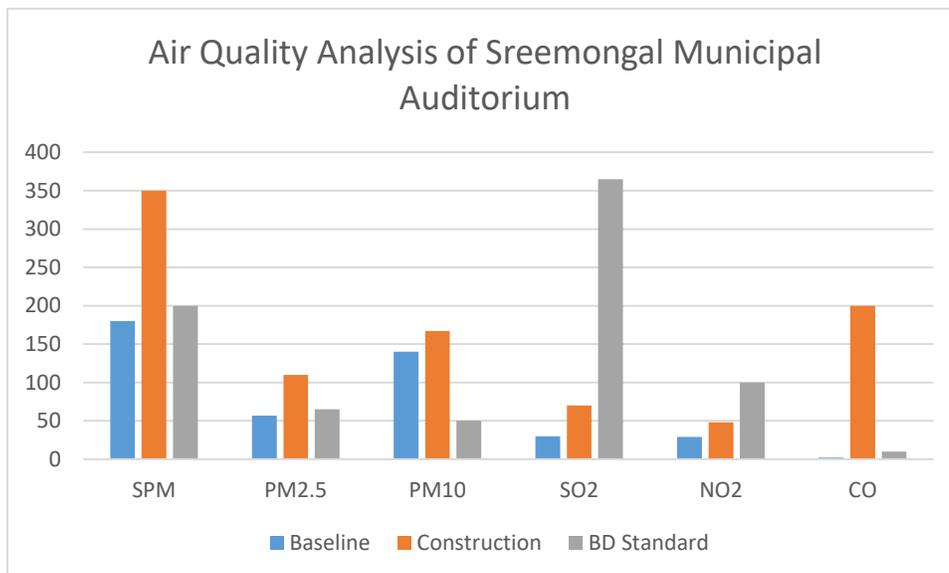
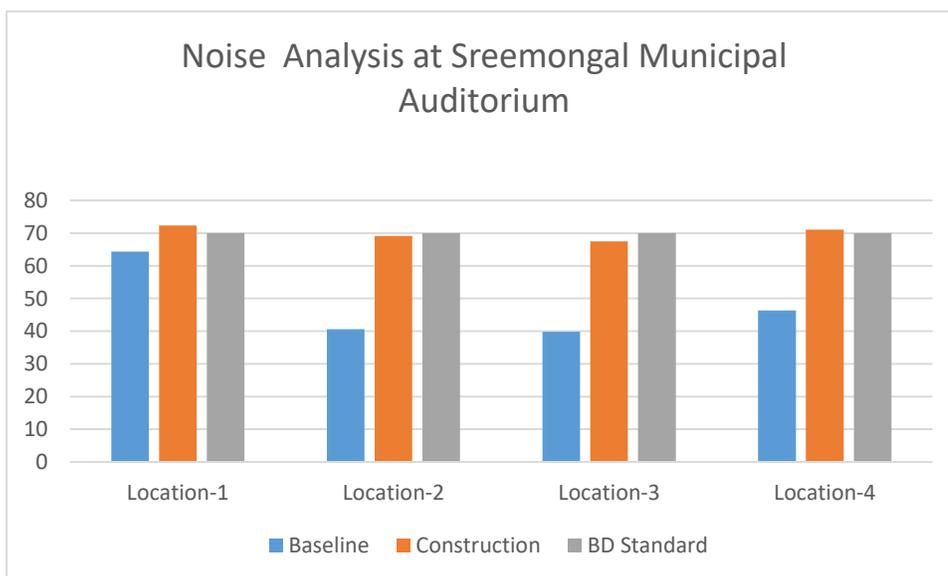
## Environmental Parameter (Air, Noise) analysis of Sreemongal Mohoshin Auditorium

Environmental parameter like air quality and noise level has been deteriorated from the baseline to construction phase. It has to be monitored that the status of environmental parameter after completion of construction works. If not the air quality do not return to it's baseline form then mitigation measures like water spray, smoke emissions from vehicle, equipment and solid waste management have to be improved. For noise control, horn, noise from vehicles, machineries have to be controlled through awareness, engaging community police and fixing signboards at strategic points around the auditorium..
